WHO IS TO BLAME FOR RESILIENT FLOORING INDENTATIONS?

Mistakes made in flooring selection or during the installation process are the usual culprits of indentations in resilient floors.

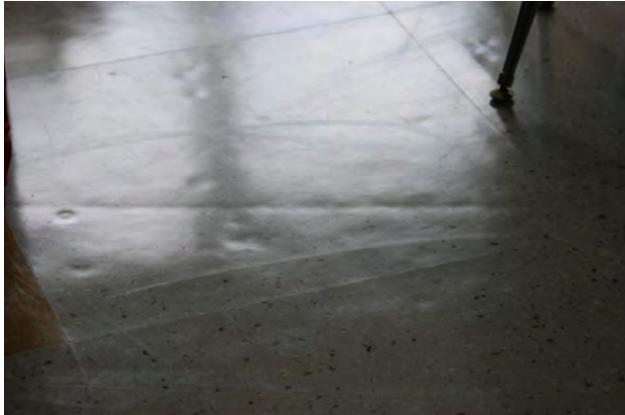
proceeding with the installation. Photo 1 shows a severe indentation in a school that originally had carpet in the classrooms. As you can see by **Photo 1**, the surface of the flooring is severely damaged, but **Photo 2** confirms the correct overall width of floor protector had been utilized on the furniture in this school (minimum 1" in diameter). Finally, **Photo 3** shows the culprit...a lack of prep work seen by residual carpet trowel ridges left behind and the new adhesive spread over the top of the old ridges. The result is adhesive displacement where excess adhesive was pushed to the perimeter of a pressure point causing indentations in the new flooring.

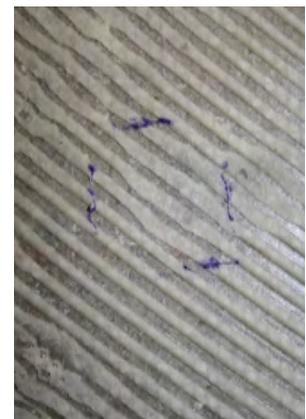
Photo 4 is a simple case of the flooring installer not rolling the floor with the recommended three section roller after placing the flooring material into the adhesive. A close look at the area beyond the indentation damage shows the ridges as they would appear before rolling. As you can see in the photo, this indentation was caused by a point load that simply flattened the ridges. The required step that was omitted left the surface of the flooring appear to be indented, but in actuality, the flooring only followed the contour of what was underneath.

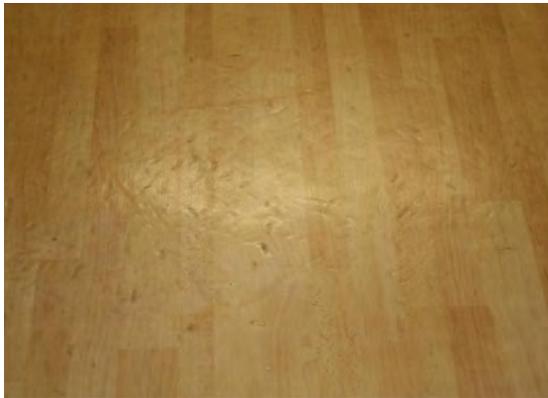
Photo 5 shows the indented surface of a floor in a hospital room under a patient bed. The flooring manufacturer’s literature called for the use of epoxy adhesive under the footprint of the bed to avoid indentations. Specialty adhesive is often required where point loads will be heavier and more abusive than usual so that the installation system can withstand the trauma of the environment. Taking the time to follow the flooring manufacturer’s instructions step by step is critical. **Photo 6** clearly shows the damage by the heavy point load of the wheels on the bed where, after investigating, it was

discovered that the adhesive specifications were not followed by the flooring installer.

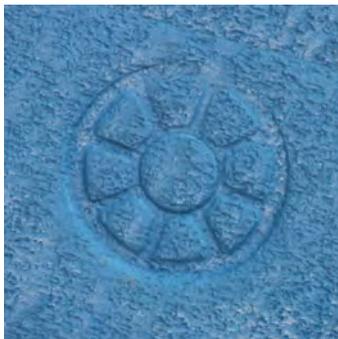
Photo 7 is a classic case of a point

load exceeding the limits of the floor and leaving a real depression in the flooring material that never fully recovered. The problem could have been eliminated with more attention to point loads during the flooring specification process or if a glide cup had been used under the equipment to disperse the load and prevent permanent damage.

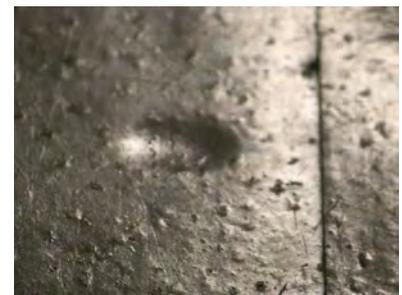
Photo 8

Last but not least, **Photo 8** shows the outcome when prep work is bypassed and holes in the concrete substrate are not patched. Indentations are typically permanent and are seldom the fault of substandard flooring material. Mistakes made in flooring selection or during the installation process are the usual culprits of indentations that cost a lot of anxiety, time and money to resolve. In almost every case, it is not the flooring
