ASTM F-710, DOES THE SUBFLOOR NEED TO BE THAT FLAT?

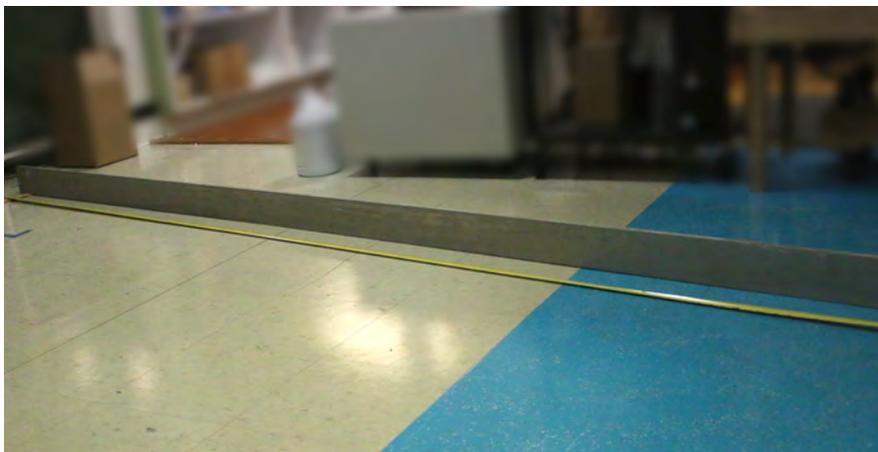
Photo 1: 10-foot Straight-edge used to gauge flatness of floor.

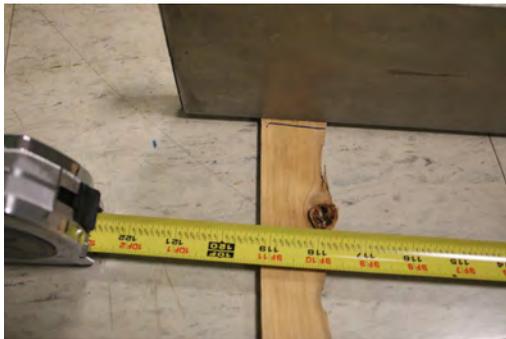
Photo 2: Plywood shim replicates maximum acceptable 3/16" deviation in height.

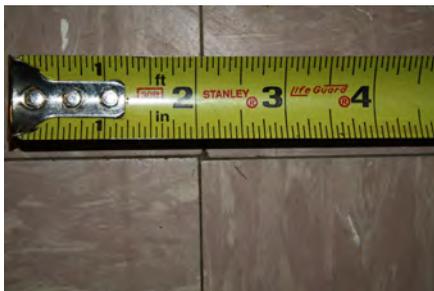
ASTM Standard F710 is a straight forward rule however a quick audit of hard-surface flooring installations indicates that most installers do not provide provisions to accommodate this ASTM standard during installation. The result can be seen in Photos 3, 4 and 5.

Photo 3: VCT run off and gaps at joints.

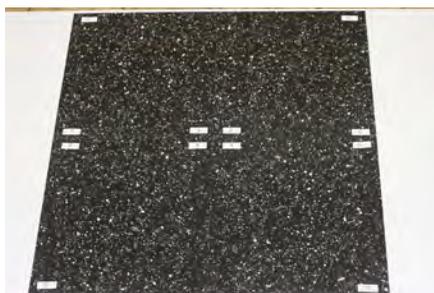
Photo 6: Set up of 4 tiles laid on a flat subfloor with tight joints and the perimeter traced.

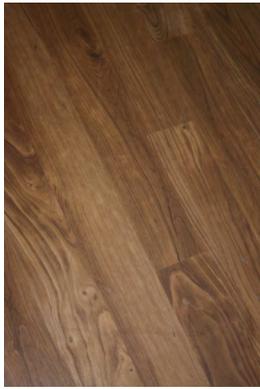
As you can see in Photo 9, when the floor meets the Standard set by ASTM F710, the modular flooring is not defective as it visually provides an acceptable finished appearance -that the manufacturer had envisioned when designing, engineering and manufacturing the flooring-with tight joints and straight lines between flooring tiles.

Photo 9: LVT installation meets ASTM-710 Standard for flat subfloor.

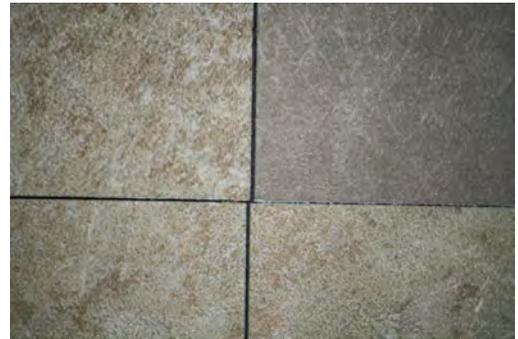
Photo 10 discloses the immediate problems created when a floor does not comply with this Standard due to a severe hump in the underfloor. Close inspection of the photograph reveals modular

components that veer to the left and to the right making it impossible to navigate the hump without gaps and misaligned corners. Even the best flooring installer cannot overcome severe undulation unless they even out the problem areas of the subfloor prior to laying the floor tiles.

Photo 10: Result of severe underfloor humps.

Replacing a floor can be expensive... especially when the flooring manufacturer is not participating in the cost so take the time to resolve sub floor issues before flooring is installed or you'll be left with a choice- rip up the just-installed floor in order to level the underfloor or live with an unattractive cut and paste job intended to conceal subfloor undulation that your flooring installer did not fix -it's your call.
