TRUE OR FALSE: TILE RUN OFF MEANS FLOOR TILES NOT SQUARE

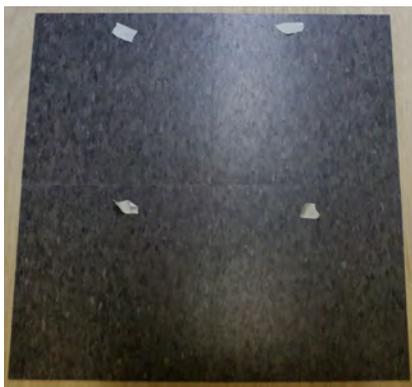
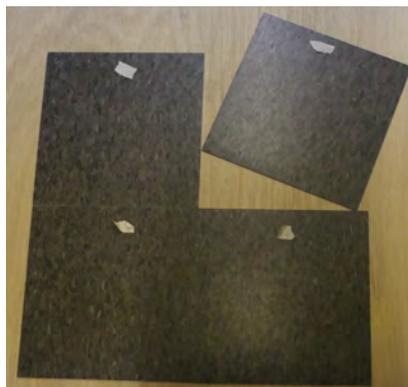
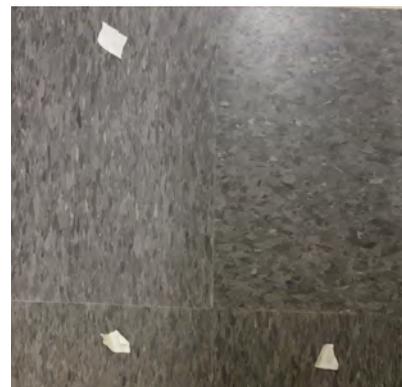
First, **check the product for square.** The simple task takes only a few minutes to execute, but determines, without a doubt, if the problem lies with the product. Assemble four (4) flooring tiles

on a flat surface running all in the same direction and mark the top of each so that it is easy to identify. Fit the tiles together so they meet at one corner with joints and edges tight to each other without any deviation. Next rotate one tile to the right 90 degrees and tighten all the tiles for smooth edges at the perimeter and tight joints at the common point of contact. Continue rotating the same tile, 90 degrees at a time, until it has been rotated 360 degrees and is finally positioned at its original starting point. Continue this process for each tile until all four tiles have been rotated successfully 360 degrees. **Note any gaps or uneven edges with a mark on the tile(s) edge. Typically if there is a problem with squareness, you will immediately identify the problem with the first tile. If you find a discrepancy, you have uncovered a visible defect (out of square) and you should stop installing the floor immediately!** This instruction is included in most flooring manufacturer literature along with directions to call the manufacturer, explain your findings and get further directions on how to proceed.

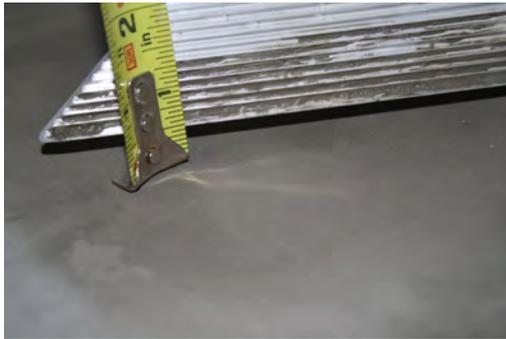
subfloors conforming to ASTM F710 for concrete and other monolithic floors or ASTM 1482 for wood floors. **Check for subfloor flatness using a true 10 straight edge.** Deviation exceeding 3/16" in ten lineal feet or the equivalent of 1/32" in 12 inches is typically too much and must be leveled prior to flooring installation per manufacturer's instructions. Ignoring this rule creates challenges in terms of maintaining a straight, true, square installation without gaps, runoff or birdeye corners -a void where tiles meet at

the corners. Laying tiles over sub floor deviations that exceed flooring manufacturer specifications will also exceed the skill set of most flooring installers and the completed installation will likely be unacceptable to the end user. To make matters worse, the finished floor will progressively look worse over time due to dirt and debris that settles in the gaps and open joints and becomes a haven for growth of bacteria and germs.
