ELIMINATE FLOORING COMPLAINTS – READ INSTALLATION INSTRUCTIONS

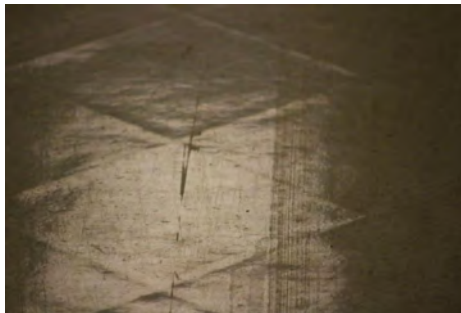
When laying new resilient sheet over existing vct floor tiles, results are not always good due to existing conditions.

closer look and capture some photos. In one instance, while attending a seminar in a municipal building, I couldn't help but notice the pattern of pre-existing 12-inch flooring tiles, likely VCT, showing through sheet vinyl flooring laid over top of it. I don't know if the facility manager put in a complaint to the flooring manufacturer but if they did, it was likely denied because most resilient sheet flooring product comes with a set of instructions that includes a disclaimer about new flooring material being installed over old floors. Flooring industry standards typically places the liability on the flooring contractor, retailer or installer when a new sheet vinyl floor is put over top of an existing floor. The recommendation is to remove old flooring material and adhesive before laying a new floor. The language in flooring manufacturer literature is more specific than that and contains certain conditions that must be met for substrates to achieve a successful flooring application.
